TECHNICAL NOTE

No. 1178

A FLIGHT INVESTIGATION OF THE THERMAL
PERFORMANCE OF AN AIR-HEATED PROPELLER

By John F. Darsow and James Selna

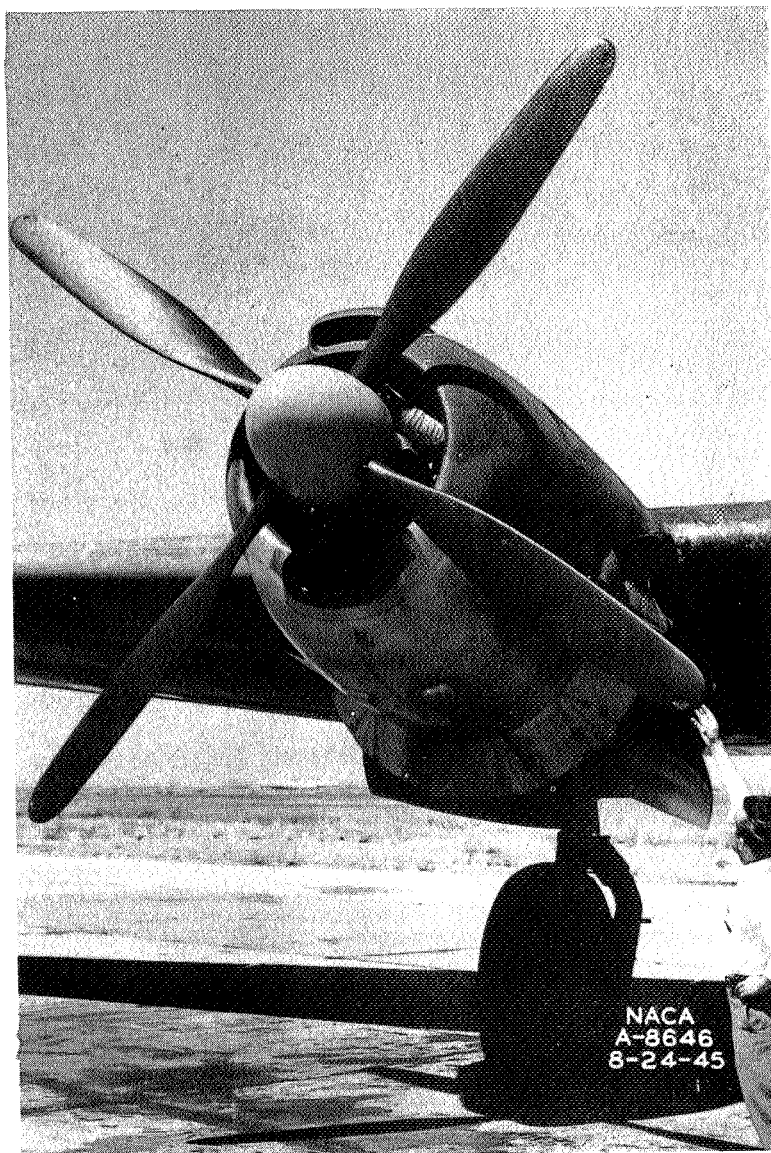
Figure 1.- Air-heated propeller installed on the right engine of the test airplane.

The test propeller, a four-blade, 14-foot-diameter, air-heated propeller was installed on the left engine of a test airplane. A similar installation, which was provided on the right engine for subsequent tests, is shown in figure 1. The operation of the propeller heating system is shown in figures 2 and 3. Ram air, heated by an exhaust-gas-air heat-exchanger installation (described in reference 2) was ducted to the stationary part of the propeller air manifold. The heated air was then transmitted to the rotating part of the propeller air manifold, admitted to the blade cavity through holes in the blade shanks, and discharged through nozzles located at the blade tips. The air particles in the blade are subject to radial accelerations, due to the rotation of the propeller, which results in a pumping action. This pumping action together with the ram pressure at the heat exchanger induced the air flow through the system. In order to reduce the air leakage between the
